INITIAL STORMWATER MASTER PLAN

PREPARED FOR:
CITY OF BRUNSWICK

PREPARED BY:
GWES, LLC

PROJECT NO. 092.01.3.19
MARCH 2020

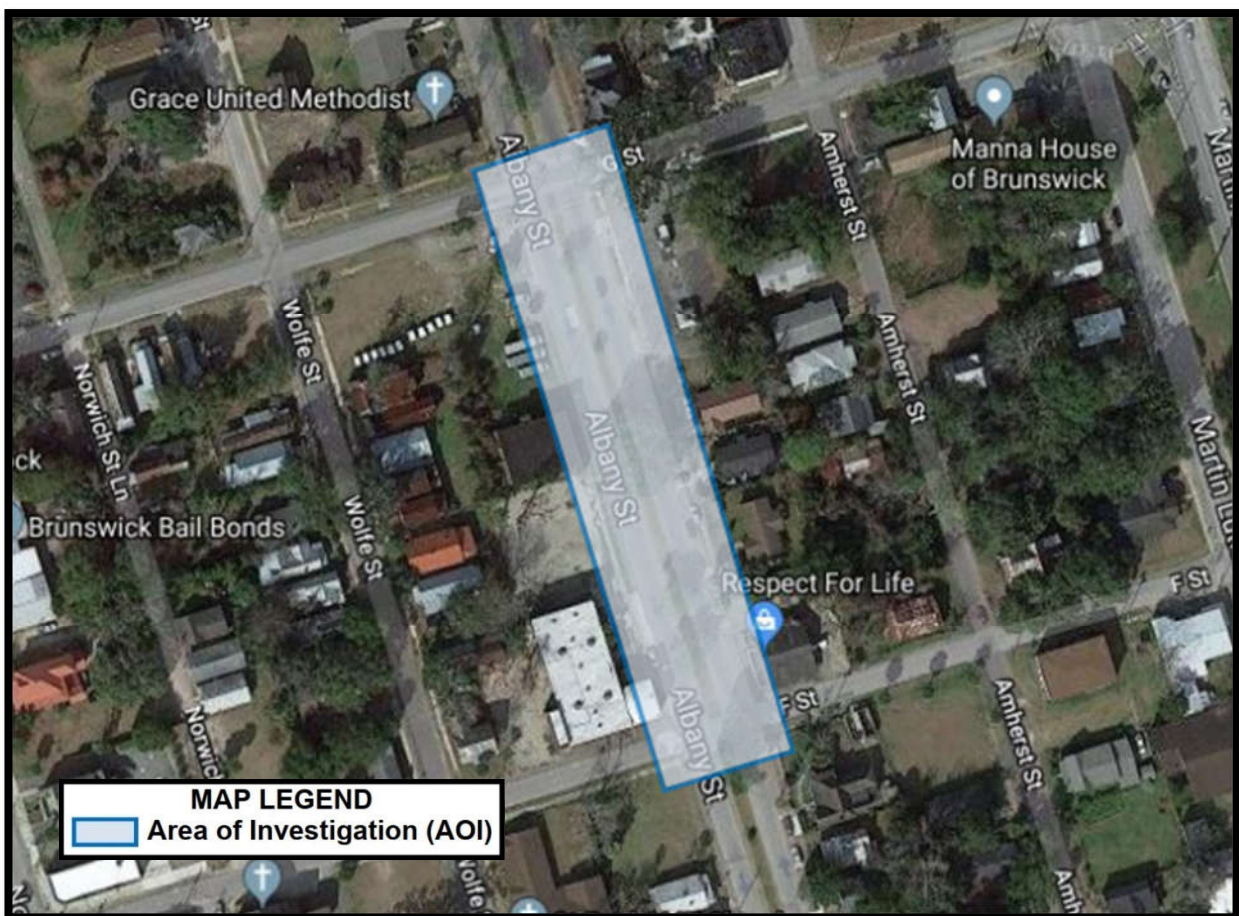
Figure 1: Albany Street (near F and G Street) AOI

Albany Street (near F and G Street)

- Severe flooding observed on both sides of Albany Street during field visit.
- Stormwater inlets were not accepting flow on east side of Albany Street.
- Stormwater was flowing in a westerly direction over the median in the middle of Albany Street.
- Flooding was occurring at intersection of Albany Street and F Street.
- Albany Street between F and G Street appears to be a low area.
- Runoff from this area eventually flows to H Street Outfall.
- The area has been the subject of stormwater complaints in the past.
- Existing infrastructure is in need of maintenance and/or replacement.
- Additional infrastructure may also be necessary to address deficiencies.

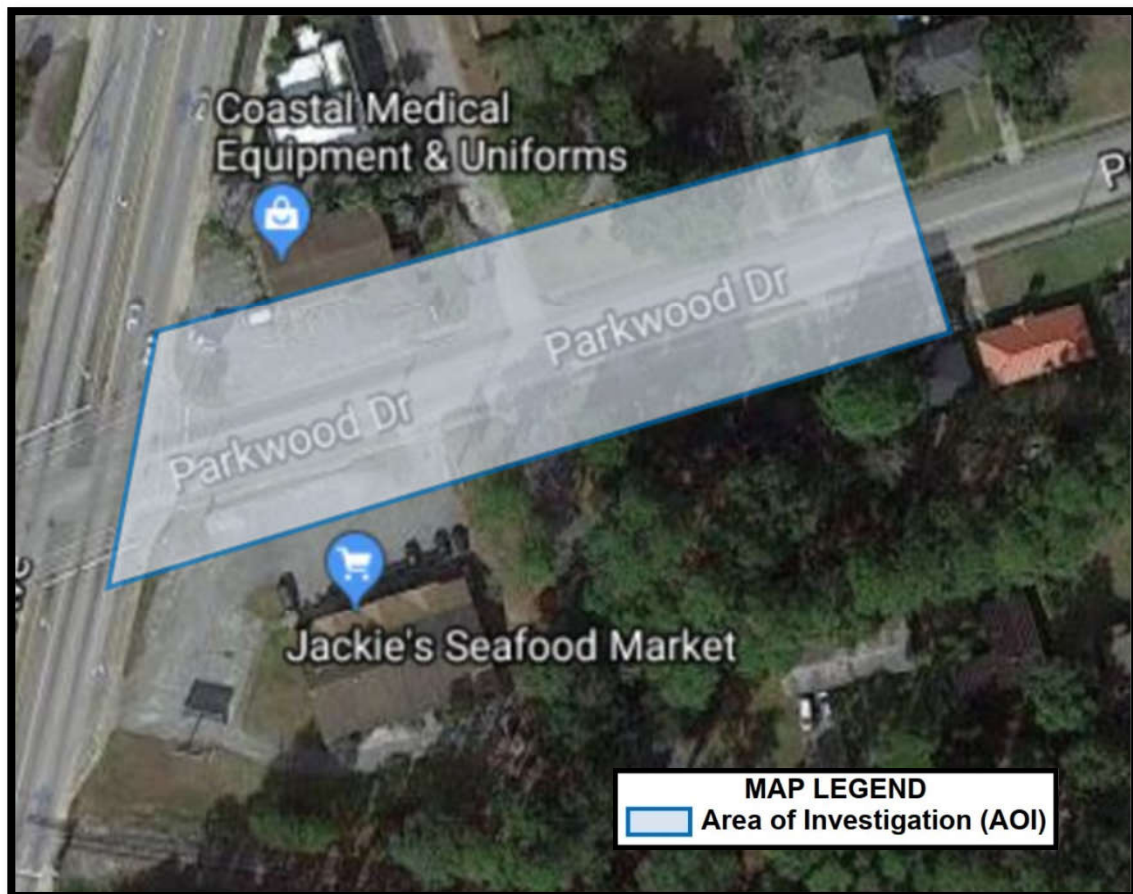
Figure 2: Parkwood Drive (West End) AOI

Parkwood Drive (West End)

- During initial field visit, the inlets were in poor condition and had not been cleaned out, containing standing water, silt and debris.
- Could not locate yard inlet connected to pipe flowing north along N Cleburne Street on the east side.
- During another field visit following a rain event, the inlet at the corner of Parkwood Drive and N Cleburne Street was not accepting flow, water was backed up in the gutter along Parkwood Drive.
- Additionally, there was standing water in the parking lots of Coastal Medical Equipment & Uniforms and Jackie's Seafood Market.
- Runoff from this area eventually flows to T Street Outfall.
- The area has been the subject of stormwater complaints in the past.
- Existing infrastructure is in need of maintenance and/or replacement.
- Additional infrastructure may also be necessary to address deficiencies.

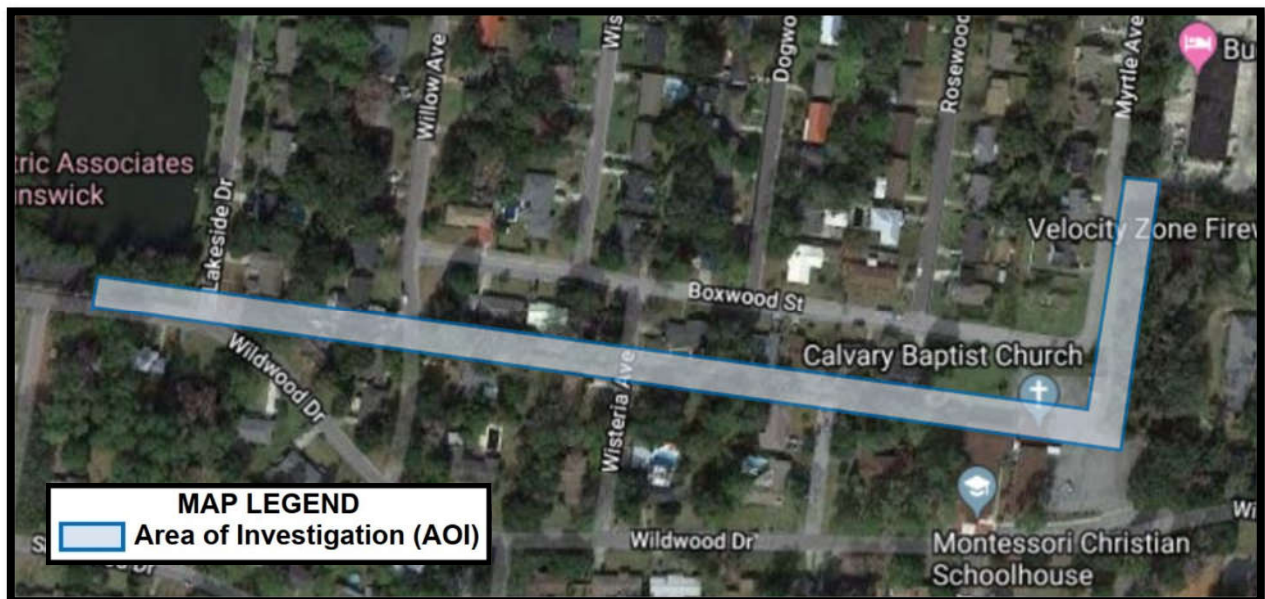
Figure 3: Wildwood Ditches (near Boxwood Street and Myrtle Avenue) AOI

Wildwood Ditch (near Boxwood Street and Myrtle Avenue)

- City replaced culvert running under Wisteria Avenue in 2018, sized according to upstream pipe capacity.
- During initial field visit, the 48" pipe system that flows adjacent to church and then makes a 90 degree turn into the ditch system flowing along Myrtle Street was $\frac{3}{4}$ full at high tide.

- Runoff from this area eventually flows to Wildwood Drive Outfall.
- The area has been the subject of stormwater complaints in the past.
- Existing ditch system may require maintenance and/or shore stabilization.

- Existing stormwater infrastructure near church (48" pipe and 90 degree junction box) and tidewater may be causing bottlenecks or tailwater issue resulting in flooding.

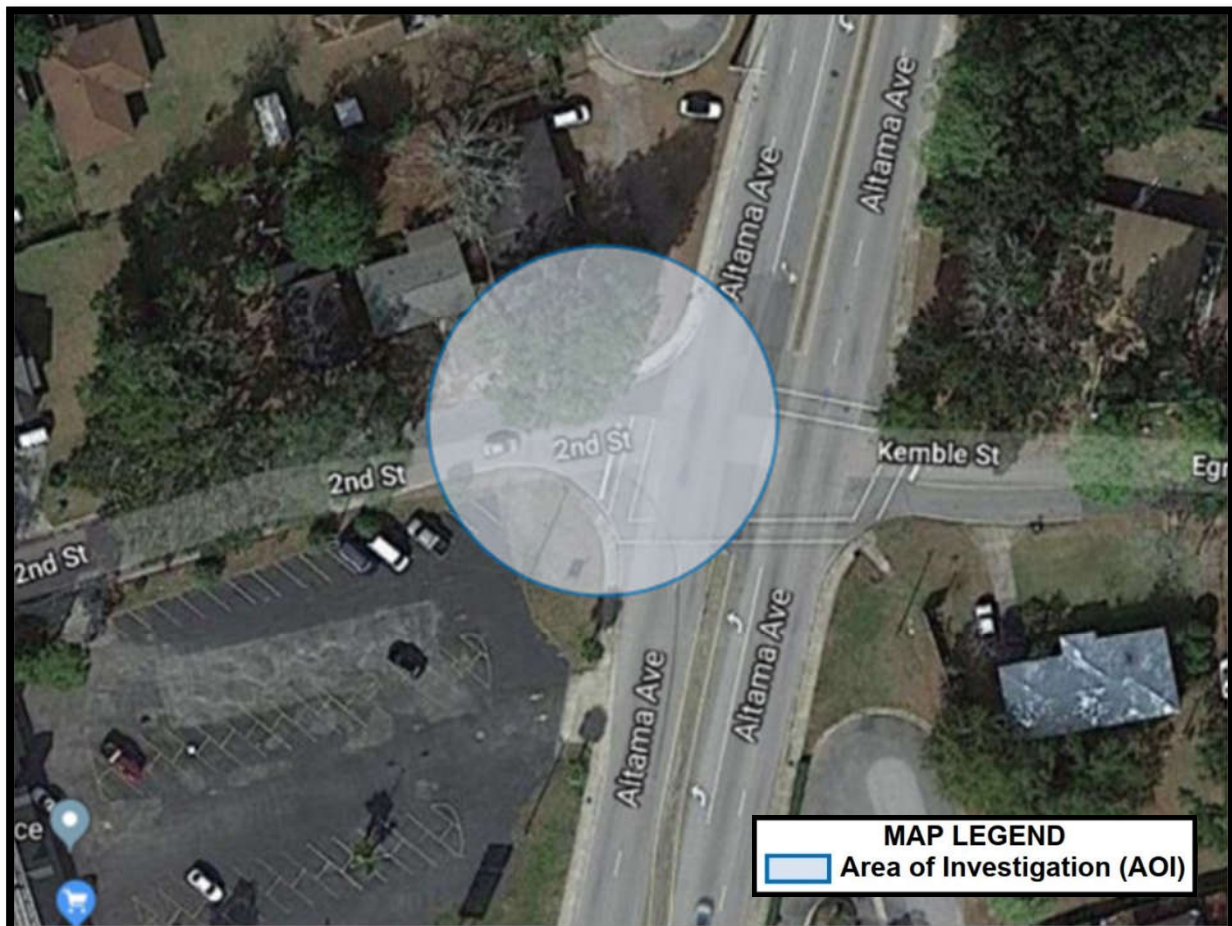
Figure 4: Altama Avenue and Second Street AOI

Altama Avenue and Second Street

- During initial field visit, the corner of Altama Avenue and 2nd Street appears to be a low spot.
- Curb and gutter is in place; however, it does not appear to flow to any existing structure.
- During another field visit following a rain event, there was some standing water in the gutter.
- Additionally, there were some flooding issues heading south along Altama Avenue in front of abandoned building, existing stormwater infrastructure does not appear to be accepting flow.
- Area does not appear to flow toward a specific outfall.
- The area has been the subject of stormwater complaints in the past.
- Area may require additional stormwater infrastructure in order to connect to existing system and reduce flooding issues.

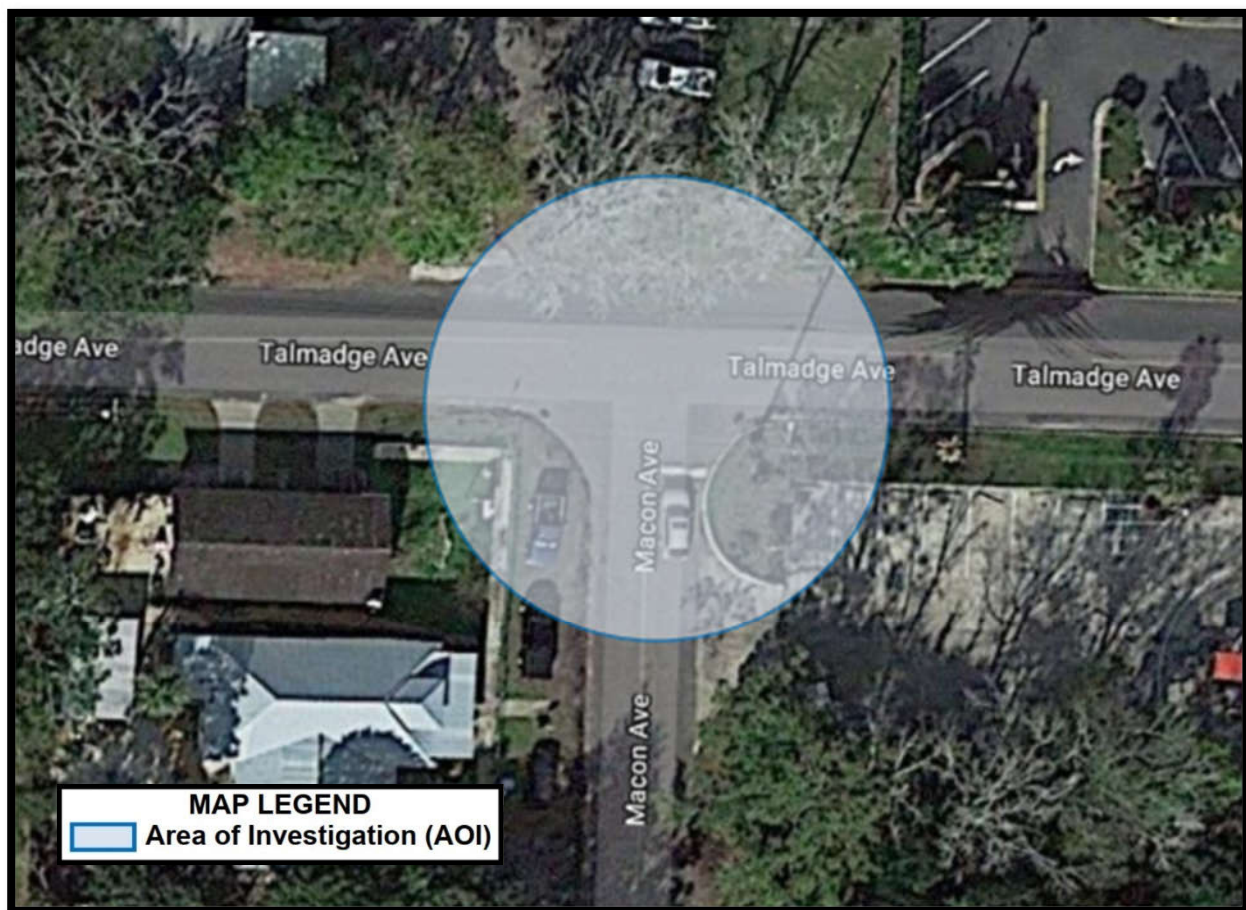
Figure 5: Intersection of Macon and Talmadge Avenue AOI

Intersection of Macon and Talmadge Avenue

- During initial field visit, inlets were in poor condition, full of water, silt, and debris.
- Inlets appear to be affected by tides as they were full of water during site visit prior to rain.
- During another field visit during a rain event, there was flooding at corner of Macon and Talmadge Avenue around inlet and along eastern side of Macon Avenue heading south.
- Runoff from this area eventually flows to unnamed outfall on eastern side of Highway 17 into marsh.
- The area has been the subject of stormwater complaints in the past, see Appendix E for work order history.
- Existing stormwater infrastructure is in need of maintenance and/or replacement.
- Area may require additional stormwater infrastructure, tidal control and/or an increase in capacity in order to reduce flooding issues.

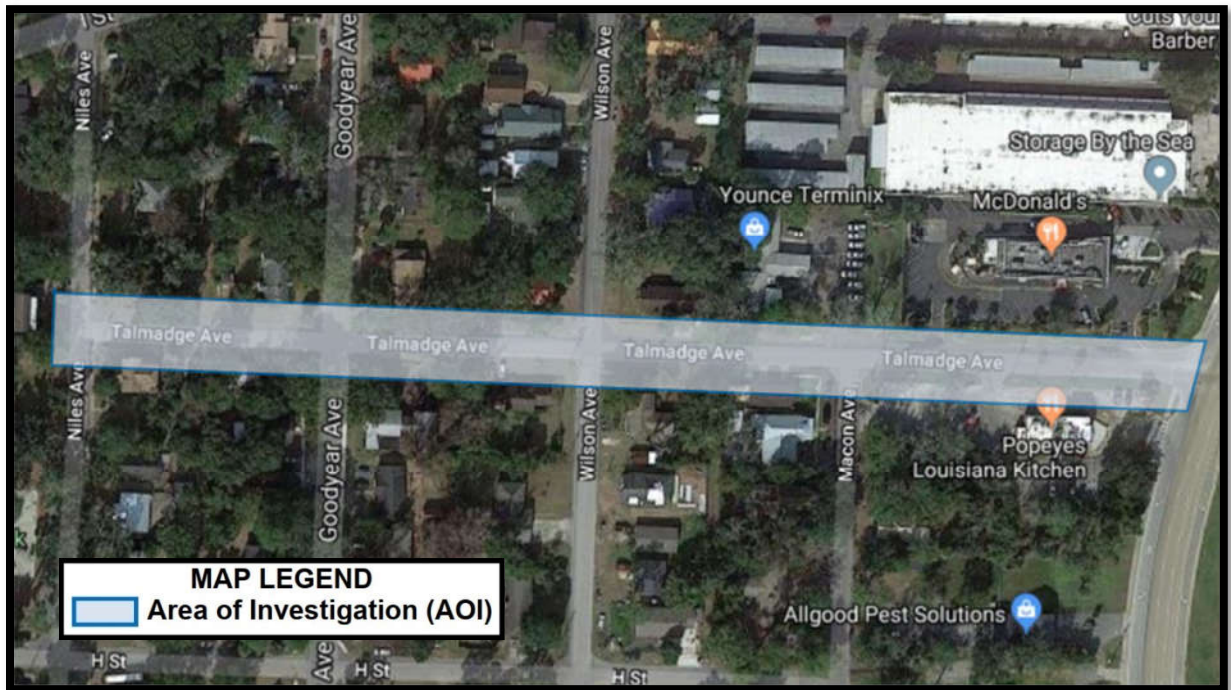
Figure 6: Talmadge Avenue Ditches AOI

Talmadge Avenue Ditches

- Talmadge Avenue does not currently have stormwater infrastructure heading west past Macon Avenue with the ability to convey water toward an outfall.
- During initial field visit, there were signs of flooding along Talmadge Avenue.
- Construction of ditches and/or installation of curb and gutter may alleviate flooding issues.

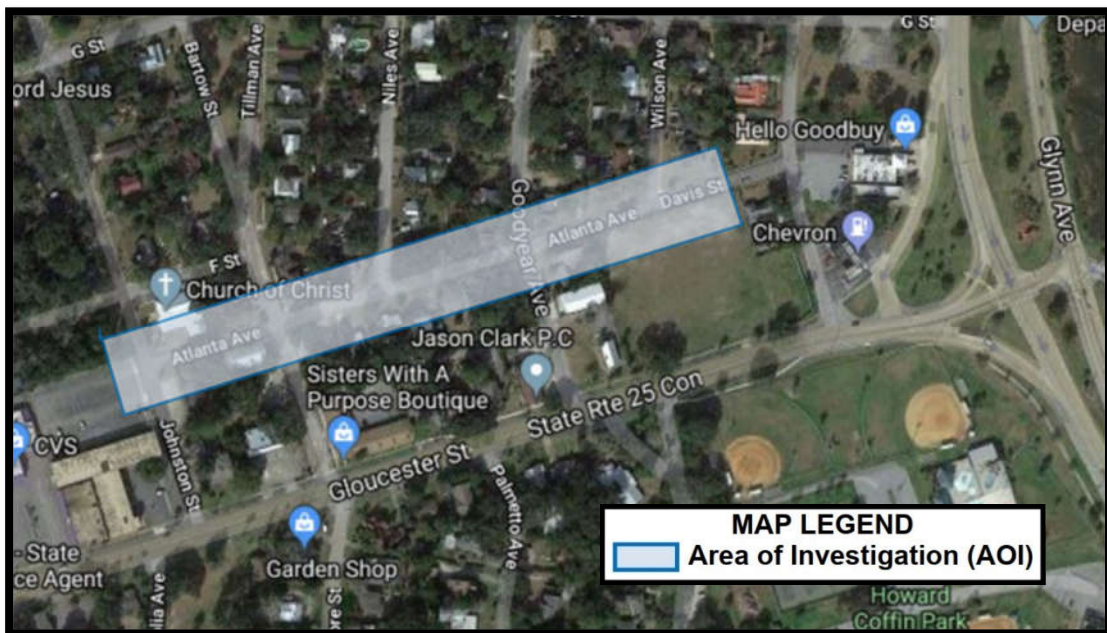
Figure 7: Urbana Neighborhood at Atlanta Avenue AOI

Urbana Neighborhood at Atlanta Avenue

- During initial field visit during a rain event, there was flooding at multiple intersections and along the sides of Atlanta Avenue in the gutter.
- At the intersections of Tillman Avenue, Goodyear Avenue and Niles Avenue with Atlanta Avenue, the inlets are in poor condition and need to be cleaned out.

- At the intersection of Wilson Avenue and Atlanta Avenue, inlet has been paved over, causing flooding issues at that corner.
 - Other inlets are in poor condition, need to be cleaned out, full of water, silt and debris.

- Debris in gutter is causing additional drainage issues.
- Runoff from this area eventually flows to Atlanta Avenue Outfall.
- The area has been the subject of stormwater complaints in the past.

- Area may require additional stormwater infrastructure, tidal control, and/or an increase in capacity in order to reduce flooding issues.

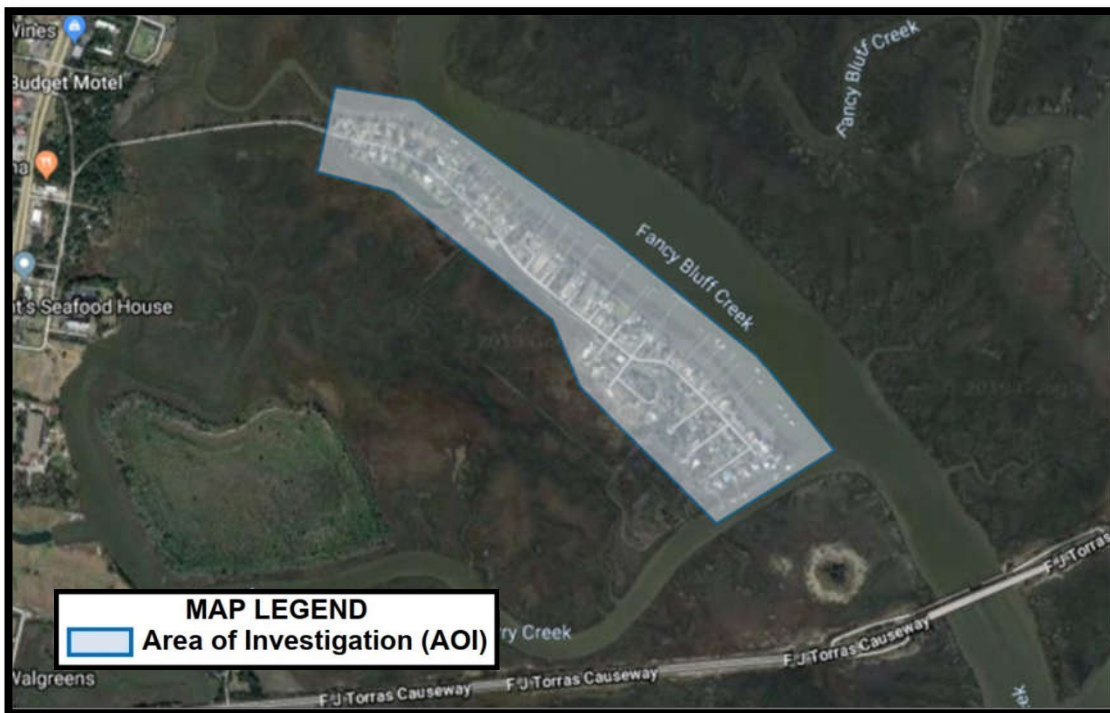
Figure 8: Riverside Neighborhood AOI

Riverside Neighborhood

- During initial field visit, there were multiple signs of flooding throughout the neighborhood including erosion, roadway damage, blocked driveway culverts, and damaged lawns.

- During another field visit following a rain event, the areas susceptible to flooding were apparent.
- Low areas with little to no infrastructure (or inadequate) appear to have the most frequent flooding issues, including Wassaw Island Circle, Julenton Island Drive, along Riverside Drive, and at the entrance to the neighborhood.

- The area has been the subject of stormwater complaints in the past.
- On-going projects in area include:
 - 1st house near entrance – replace drive culvert and install inlet to marsh

- Talahi Island Lane – connect to existing system w/ pipe replacements
- Area may require additional stormwater infrastructure, tidal control and/or an increase in capacity in order to reduce flooding issues.

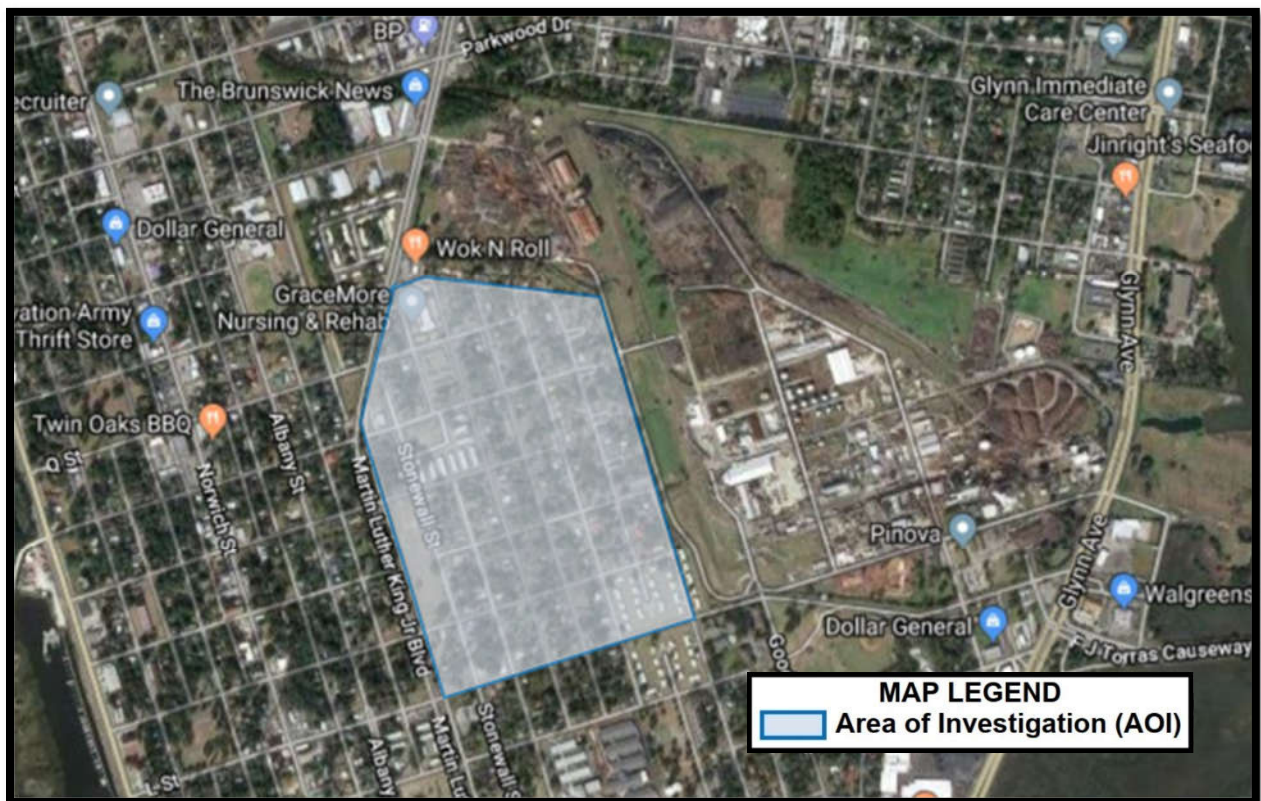
Figure 9: P Street Basin AOI

- During recent field visit following a rain event on October 15th, roadway surfaces were in poor condition. It was clear that there were flooding issues at multiple intersections, and stormwater infrastructure was in need of maintenance and/or repair.
- The area has been the subject of stormwater complaints in the past.

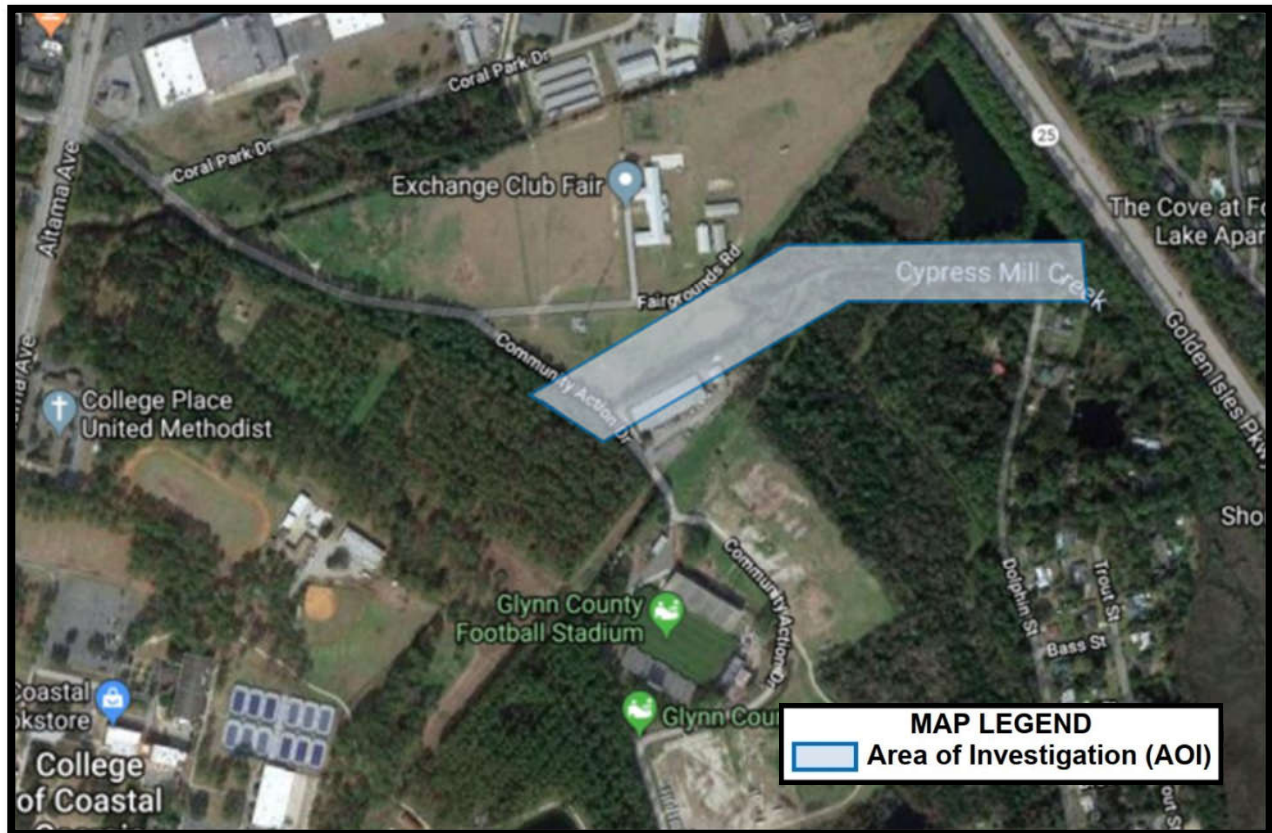
Figure 12: Magnolia Park Outfall to Fairgrounds AOI

- During a recent field visit, the four (4) pipes running under Community Action Drive were 1/2 full at high tide with no recent rain.
 - The outlet side of pipes are partially filled with sediment.
 - The inlet side remains clean.
 - A tailwater exists.
- The system does not flow into the large pond near Golden Isles Parkway (appears to be freshwater).
- The Magnolia Park Outfall is located at the end of Dolphin Street, downstream of where two ditch systems converge and Dolphin Street drains into Cypress Mill Creek through a 24" RCP.
- The area has been the subject of stormwater complaints in the past.
- To reduce potential flooding issues, capacity of infrastructure may need to be increased and/or tidal control structures may be necessary.

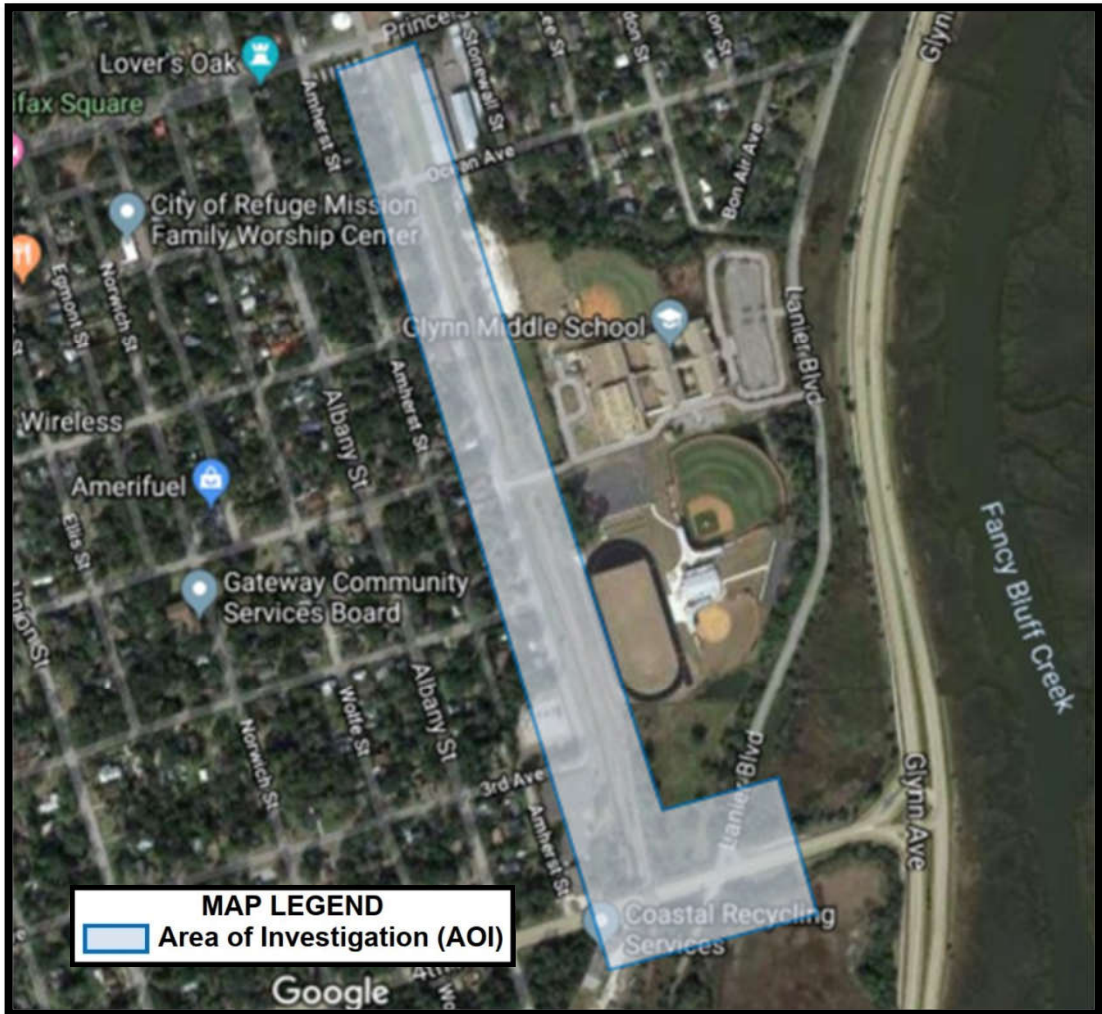
Figure 13: Habersham Park AOI

- During a recent field visit during a rain event, ditches were overgrown with vegetation, and stormwater infrastructure was in need of maintenance and/or repair.
- To reduce potential flooding issues, capacity of infrastructure may need to be increased, tidal control structures may be necessary, and/or divert flow to another outfall if feasible.

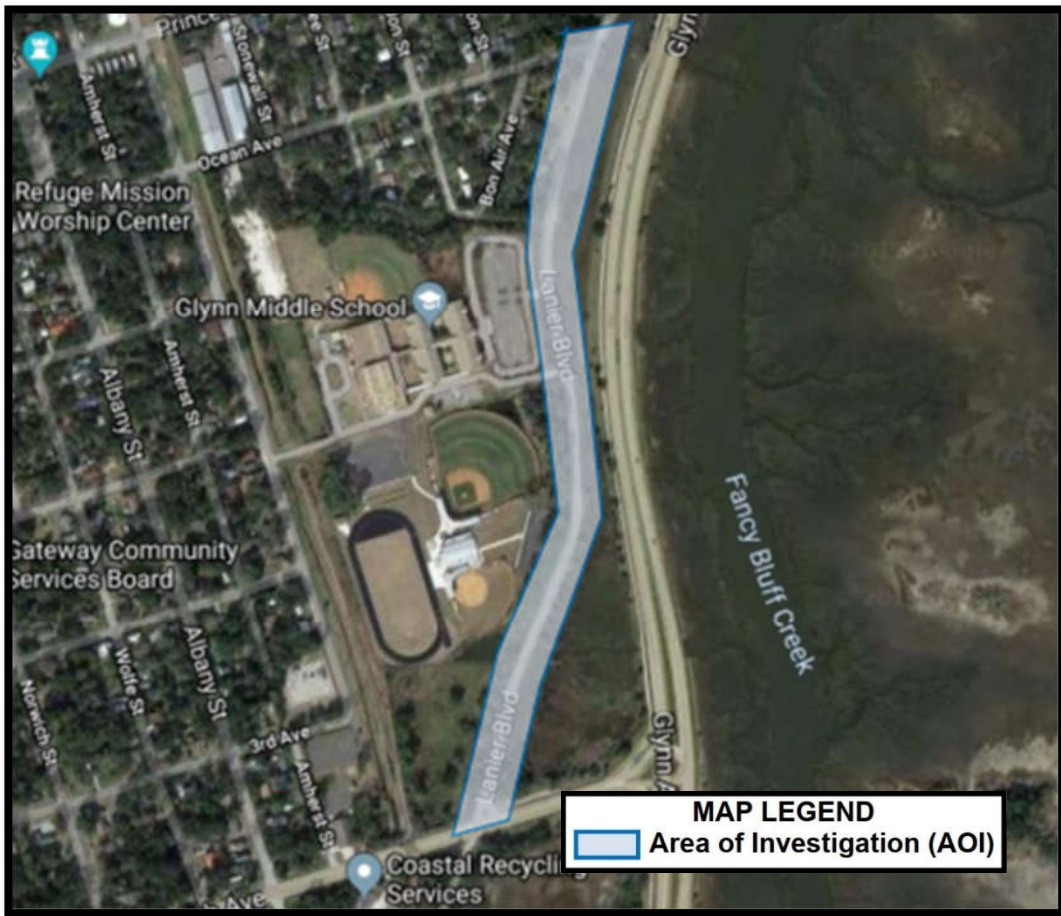
Figure 14: Lanier Boulevard at GMS AOI

- During a recent field visit during a rain event, parts of Lanier Boulevard were under construction, ditches were near capacity, stormwater pipes under Lanier Boulevard were surcharged, and tidewater was flowing into outfall/Lanier system.
- The area has been the subject of stormwater complaints in the past.
- To reduce potential flooding issues, capacity of infrastructure may need to be increased, tidal control structures may be necessary, and/or divert flow to another outfall if feasible.

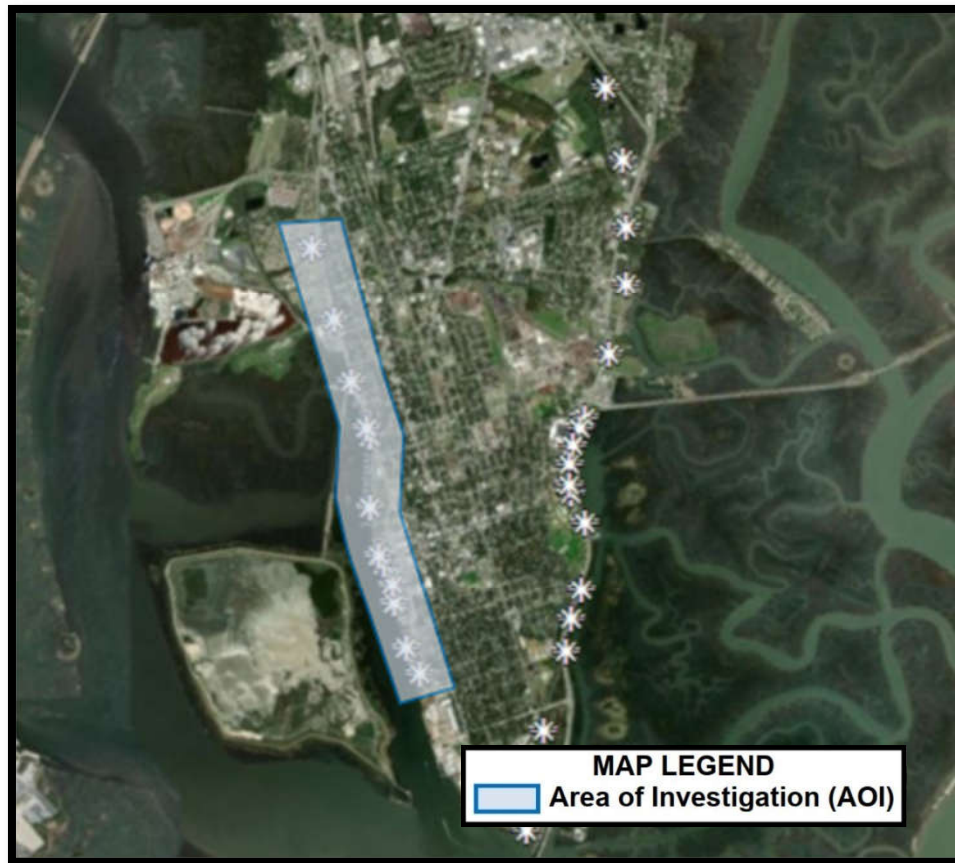
Figure 15: Ports Authority – Tide Control AOI

- During on-site field reconnaissance performed by others, it appears the majority of outfalls did not contain tide control, multiple outfalls were completely submerged based on the tide elevation, and/or the location was not accessible
- To reduce inland flooding issues, tide control may need to be installed either at the outfall or upstream location depending upon permitting issues and cost

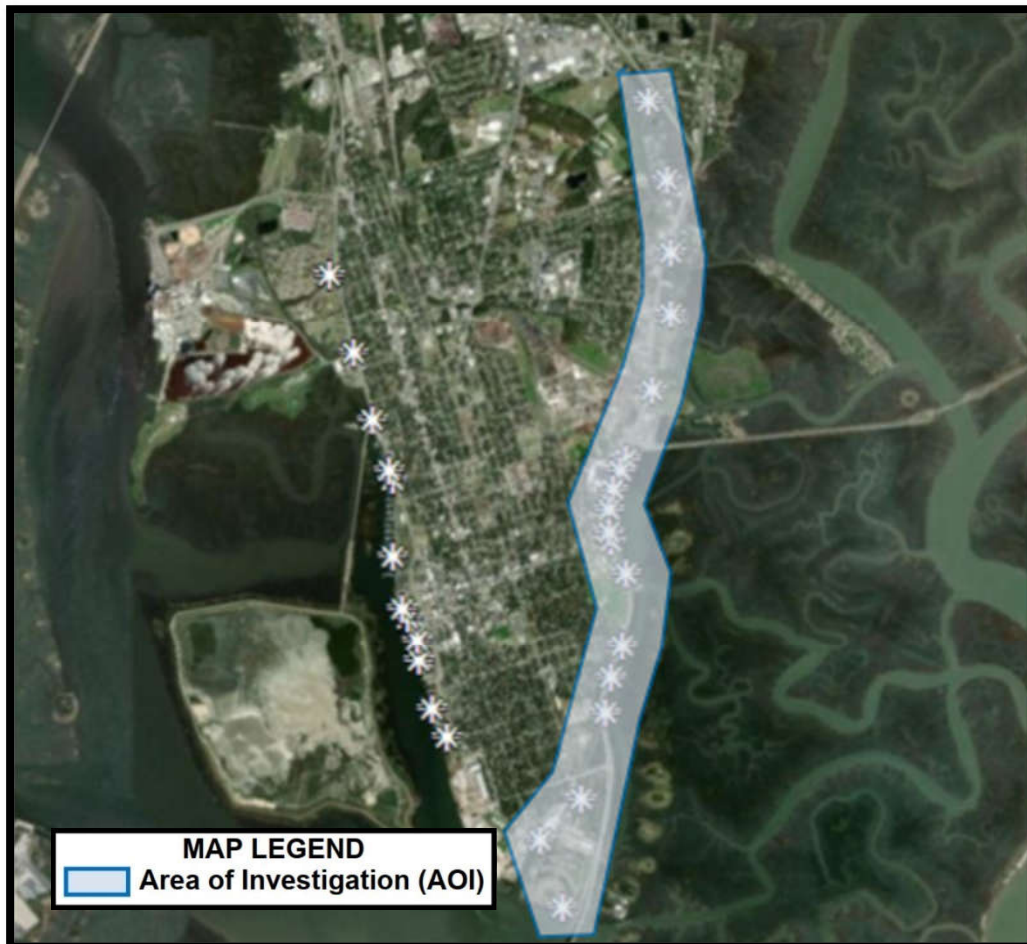
Figure 16: Highway 17 Tide Control AOI

- During a recent field visit, the majority of outfalls do not contain tide control, multiple outfalls were completely submerged based on the tide elevation, and multiple outfalls were surrounded by marsh debris and trash, see Appendix C for photos and Appendix D for field visit notes at each outfall
- To reduce inland flooding issues, tide control may need to be installed either at the outfall or upstream location depending upon permitting issues and cost
