INITIAL STORMWATER MASTER PLAN

PREPARED FOR:
CITY OF BRUNSWICK

PREPARED BY:
GWES, LLC

PROJECT NO. 092.01.3.19
MARCH 2020

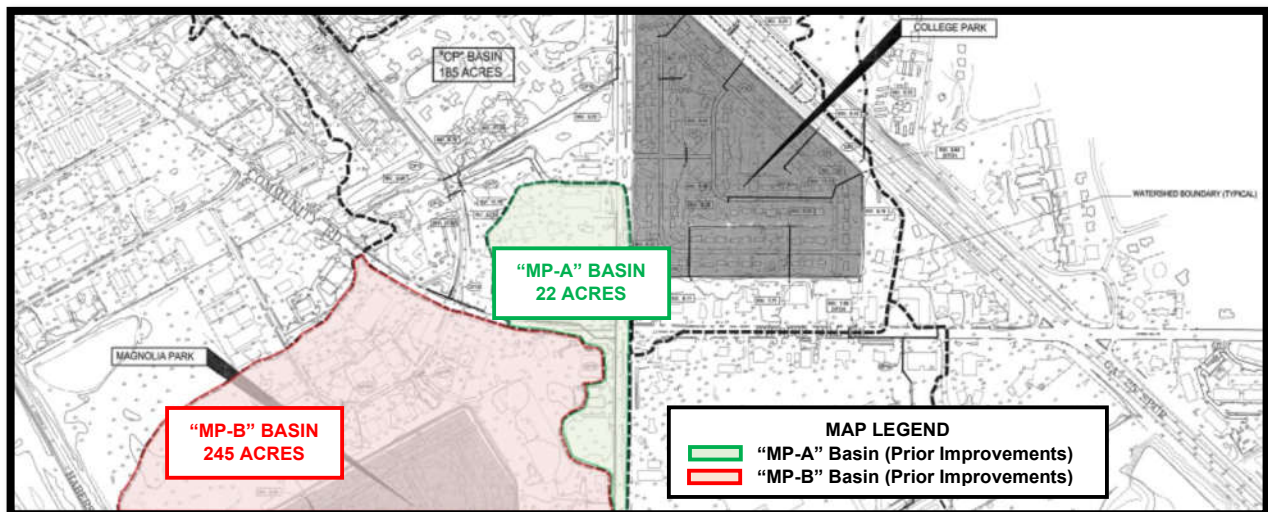
Figure 10: MP-A and MP-B Basin Map

The next effort was the *Watershed Drainage Study for College and Magnolia Park* dated June 2006 prepared by Stantec, which analyzed the capacities of existing storm drainage infrastructure in and surrounding Magnolia Park. Based on recommendations in the study, the first phase of improvements (Improvement MP-A) was constructed and completed in December 2011. Other recommendations in the study called for improvements (Improvement MP-B) to the perimeter drainage ditch that were not a part of the original February 2000 contract.

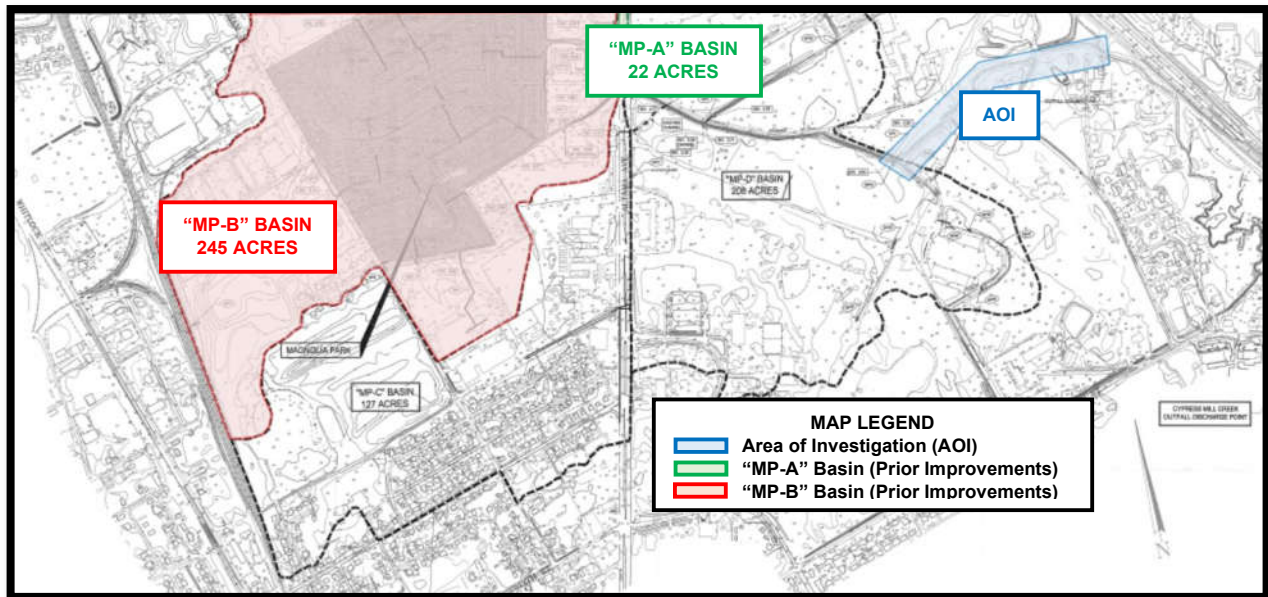
Figure 11: MP-A and MP-B Basin Map w/ AOI

The *Magnolia Park Storm Drainage Improvements Phase II* design, dated August 2012, included Improvement MP-B, dealt with improvements to the perimeter drainage ditch and storm drainage infrastructure. The project was completed in March 2014 and consisted of the installation of approximately 700 linear feet (LF) of storm drainage piping, storm drainage yard inlets, grading of upstream and downstream channel, and approximately 25,000 ft² of grout filled erosion control mattress.

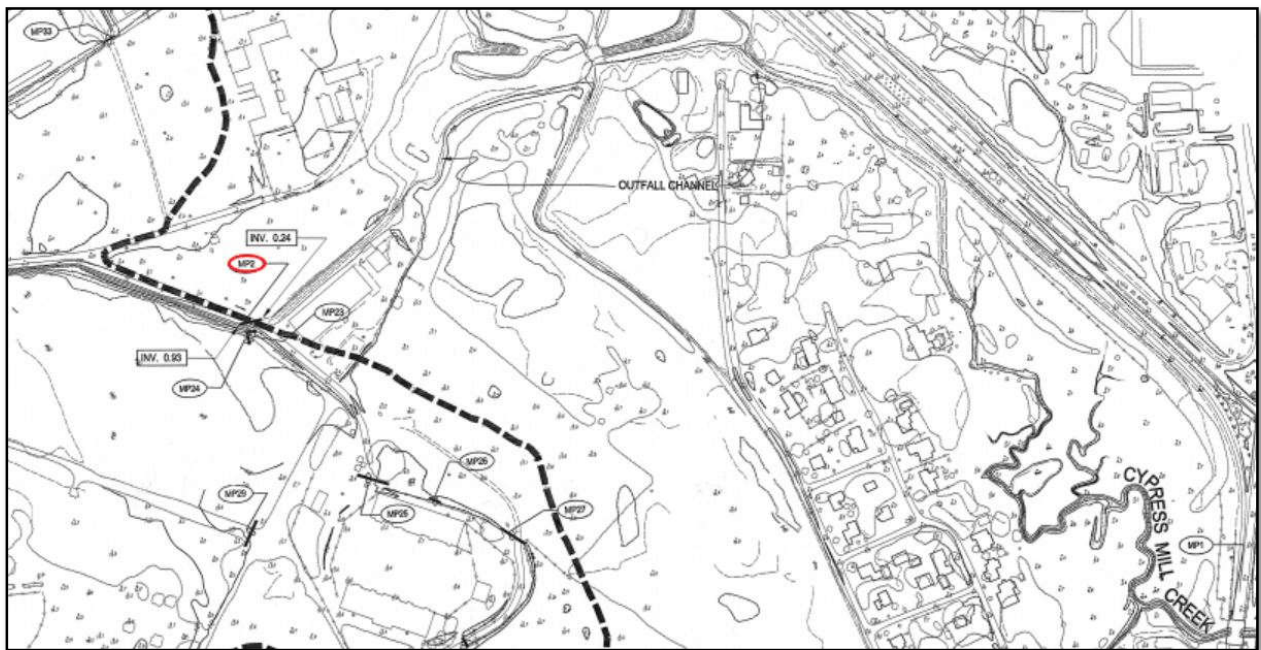
Figure 18: MP2 Structure Location

CITY OF BRUNSWICK, GEORGIA COLLEGE PARK/ MAGNOLIA PARK DRAINAGE STUDY															
EXISTING DRAINAGE STRUCTURES															
WATERSHED BASIN: MP – MAGNOLIA PARK															
STRUCTURE IDENTIFIER	LOCATION OF DRAINAGE STRUCTURE	STRUCTURE DESCRIPTION	CROSS SECTIONAL FLOW AREA (S.F.)	THEORETICAL EXISTING STRUCTURE CAPACITY (1) (cfs)	WATERSHED DRAINAGE AREA (ACRES)	ESTIMATED EXISTING CONIDON DISCHARGES FOR STORM EVENTS, cfs (2)						STATUS (3)		COMMENTS	
						2 YEAR	5 YEAR	10 YEAR	25 YEAR	50 YEAR	100 YEAR	STRUCTURE ADEQUATE FOR 25 YEAR STORM			
													YES	NO	
MP2	B.O.E. ACCESS ROAD	TRIPLE 60" RCP	56.9	510 (o)	802	170	257	349	463	546	648	X

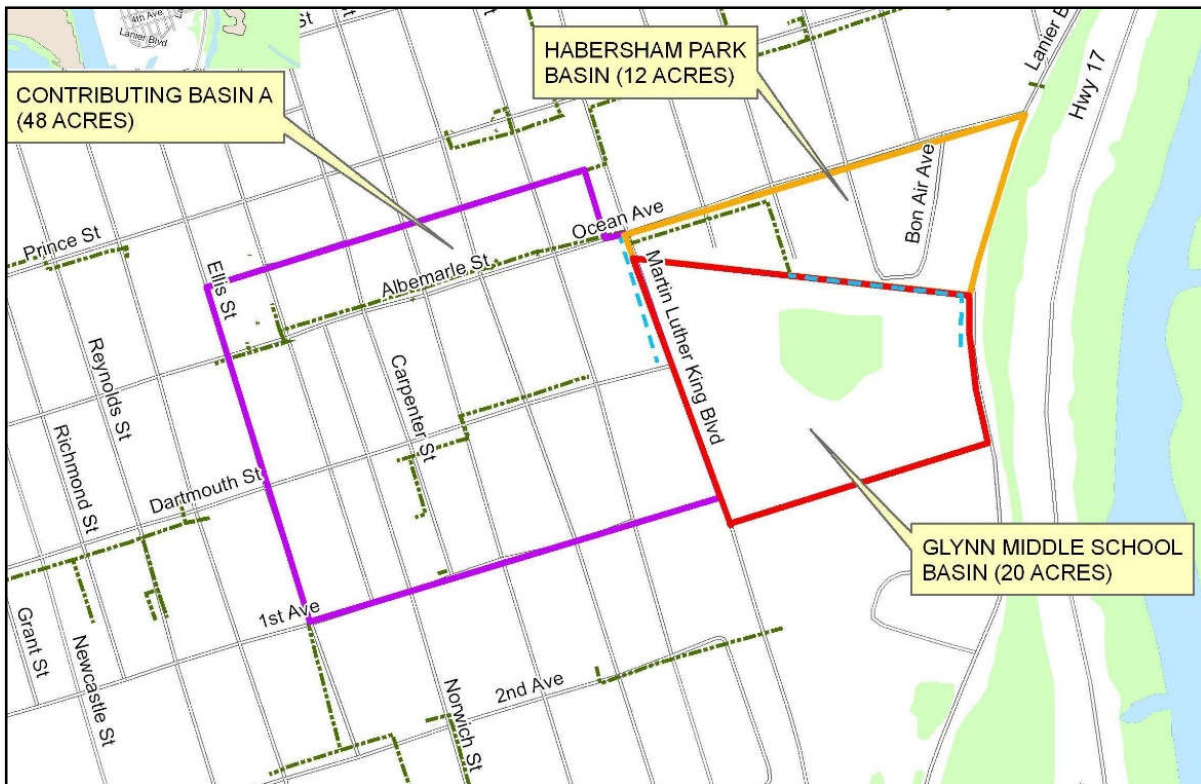
Figure 19: Drainage Basin Summary Map

- Runoff from all three drainage basins is routed through Channel "A" which lies between GMS and Habersham Park. ($Q_{25}=220$ cfs)
- A 36" pipe under Lanier Blvd. passes runoff from Channel "A" to the marsh between Lanier Blvd. and Highway 17. ($Q_{36" \text{ Pipe}} = 47$ cfs)
